SCProbond™ Wear Solutions in Limestone Conveyance

Customer Testimonial

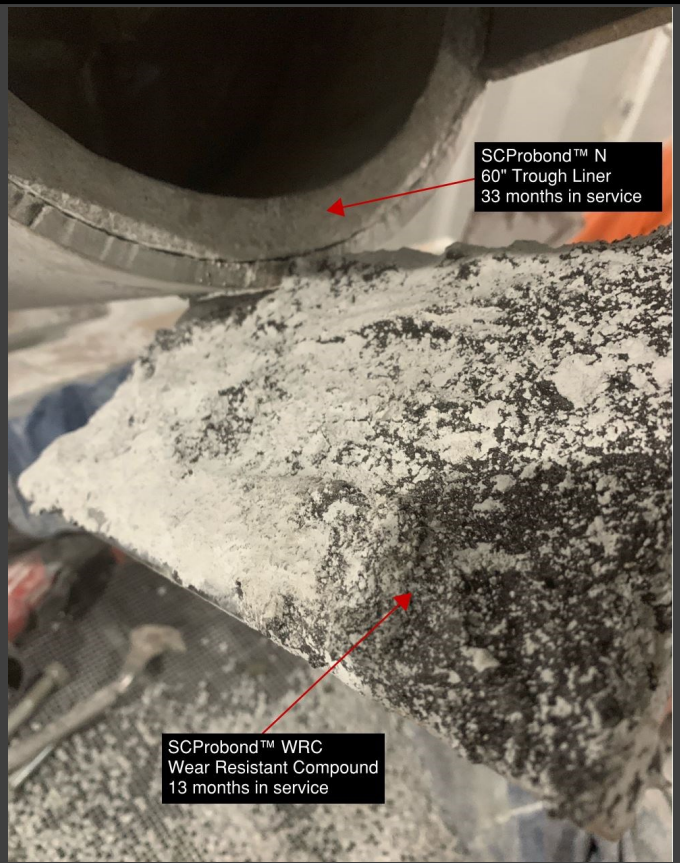
SCProbond™ N
60" Trough Liner
33 months in service

SCProbond™ WRC
Wear Resistant Compound
13 months in service

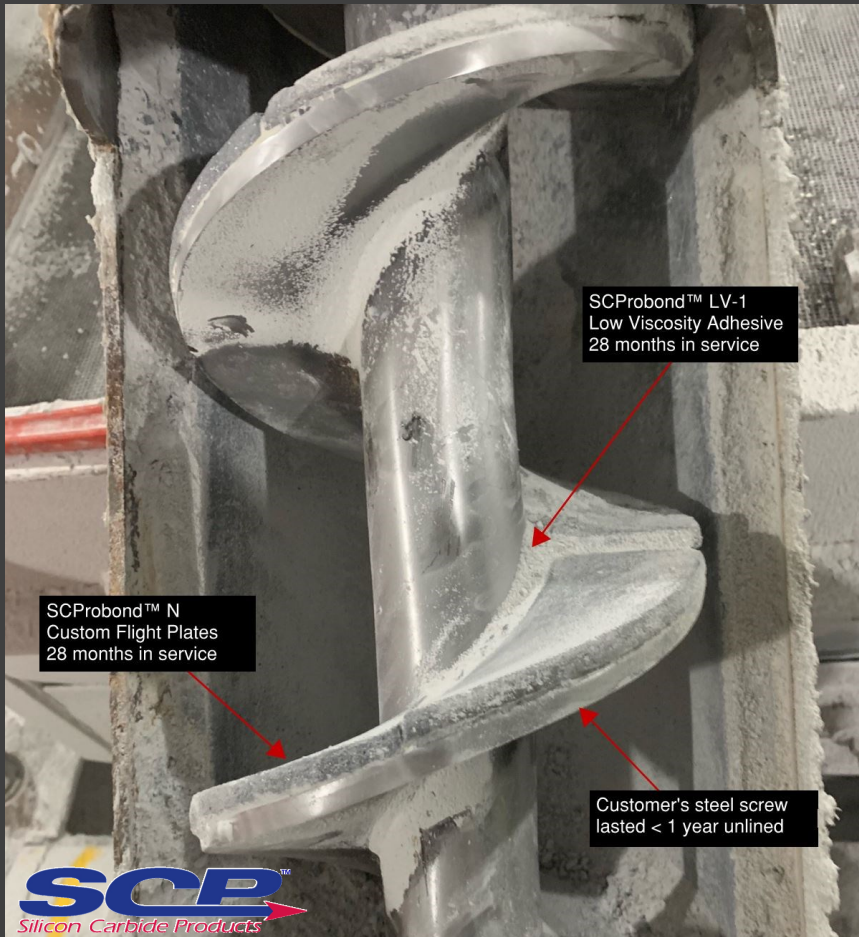
SCProbond™ LV-1
Low Viscosity Adhesive
28 months in service

SCProbond™ N
Custom Flight Plates
28 months in service

Customer's steel screw
lasted < 1 year unlined

This customer asked if SCP could manufacture a SCProbond™ N lining for their screw conveyor to keep the flights from losing diameter. We were provided with the dimensions of the both the screw and housing and got to work on these contoured 90 degree flight plates that have extended the conveyor lifetime over 20 months and counting.
